丹巴县梅龙沟“6.17”泥石流灾害链调查

摘 要: 2020 年 6 月 17 日, 四川省甘孜州丹巴县半扇门乡梅龙沟暴发大规模泥石流灾害, 形成暴雨-泥石流-滑坡-堰塞湖-洪涝灾害链。在前期短历时强降雨激发下, 梅龙沟沟道径流沿途铲刮沟道松散堆积物, 泥石流冲出量约 $2.4 \times 10^5 \text{ m}^3$, 进入主河约 $1.3 \times 10^5 \text{ m}^3$, 形成堰塞坝; 自然溃流后的泥石流坝残体挤压小金川河, 迫使河水冲刷掏蚀对岸阿娘寨古滑坡坡脚, 引发红梁木包包和烂水湾两处次级滑坡。古滑坡因之局部失稳复活, 约 $6.6 \times 10^6 \text{ m}^3$ 坡体变形剧烈, 坡体整体下挫, 表面拉裂缝发育, 强变形区边缘裂隙已经贯通, 整体处于不稳定状态。分析表明, 丹巴县梅龙沟灾害具有典型的灾害链生效应, 严重危及上下游。现场监测表明, 阿娘寨古滑坡整体滑动可能性大, 如失稳后可能形成大规模堰塞湖, 危险性极高, 应提前防护应对。

Investigation of the “6.17” Debris Flow Chain at the Meilong Catchment of Danba County, China

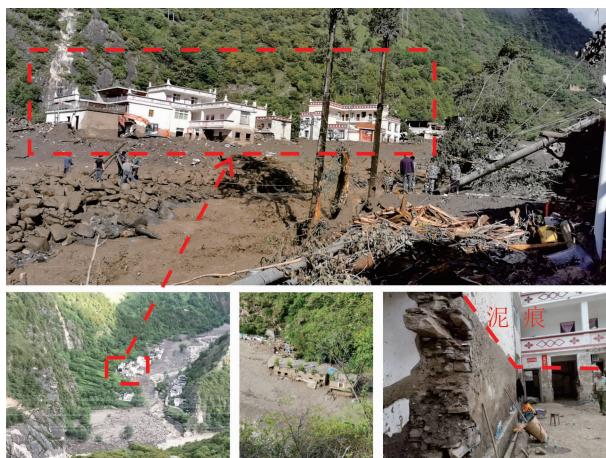
泥石流堆积体物质组成以硅质岩、板岩、砂岩碎块石、砂土为主,分选差,块石含量 30%~40%,大部分粒径约 0.1~0.5 m,最大粒径约 3~5 m。泥石流导致沟口附近大量房屋和农田被掩埋(图 3);冲出沟口的堆积体导致小金川河向左岸改道约 20 m,对岸岸坡在水流的强冲刷和掏蚀作用下失稳破坏,诱发红梁木包包滑坡和烂水湾滑坡,后来两者连为一体,造成 G350 公路烂水湾段道路中断(图 1、图 4)。

图3 梅龙沟泥石流淤埋房屋

Fig. 3 Houses buried by the debris flow at Meilong catchment

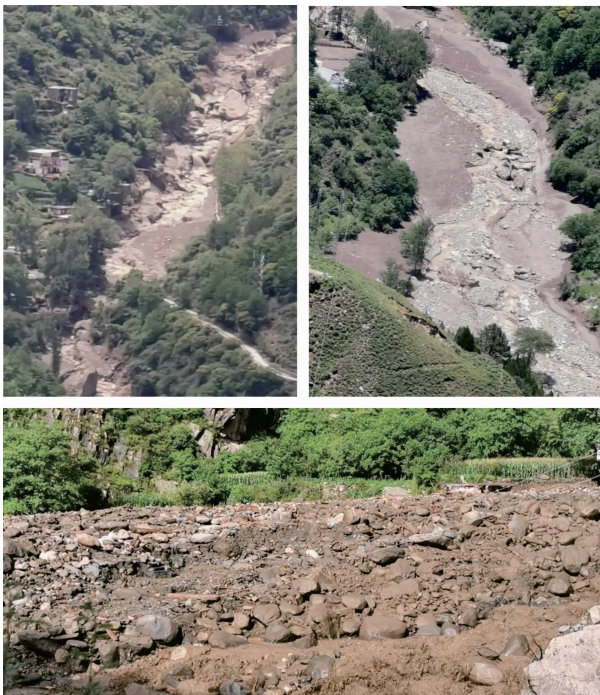
部、西北部、中部和川西高原局部降大到暴雨。据当地气象局资料显示,此次强降雨于 16 日 23:40 开始,主要集中于丹巴县的巴旺乡、半扇门乡、东谷镇、巴底镇,小时最大降雨量达 34.1 mm,雨强超 50 年一遇规模,3 小时降雨量高达 61.7 mm。基于卫星遥感反演的 GPM 降雨量数据显示,该处区域降雨强度在泥石流发生前约 2h 达到最大值,约 $11.28 \text{ mm} \cdot \text{h}^{-1}$;发生前一小时雨强高达 $11.10 \text{ mm} \cdot \text{h}^{-1}$,且泥石流发生时的累计降雨量约 30 mm(图 5)。梅龙沟流域面积高达 63.2 km^2 ,沟道汇水面积大,地形陡峭,相对高差大,短时强降雨易形成强地表径流,为松散物源启动提供了较好的水动力条件。梅龙沟流域内物源主要为沟道松散堆积物,储量较为丰富,块石粒径分布范围广(图 6)。由于主沟纵坡大,强地表径流在主沟内汇集后具有强冲刷力,沿途铲刮原沟道内堆积物,使其侵蚀启动形成沟谷型泥石流。

图6 梅龙沟沟道堆积松散物源

Fig. 6 Debris-flow deposits in the channel of Meilong

“6.17”梅龙沟泥石流系由短时强降雨激发的过渡型泥石流,物源主要来源于沟道松散堆积物,一次冲出量约 $2.4 \times 10^5 \text{ m}^3$,进入主河道约 $1.3 \times 10^5 \text{ m}^3$,形成典型的泥石流—堰塞湖—溃决洪水—古滑坡复活灾害链。梅龙沟沟道内物源仍比较丰富,在强降雨条件下可再次暴发泥石流堵塞小金川河,进而影响对岸古滑坡的稳定性。

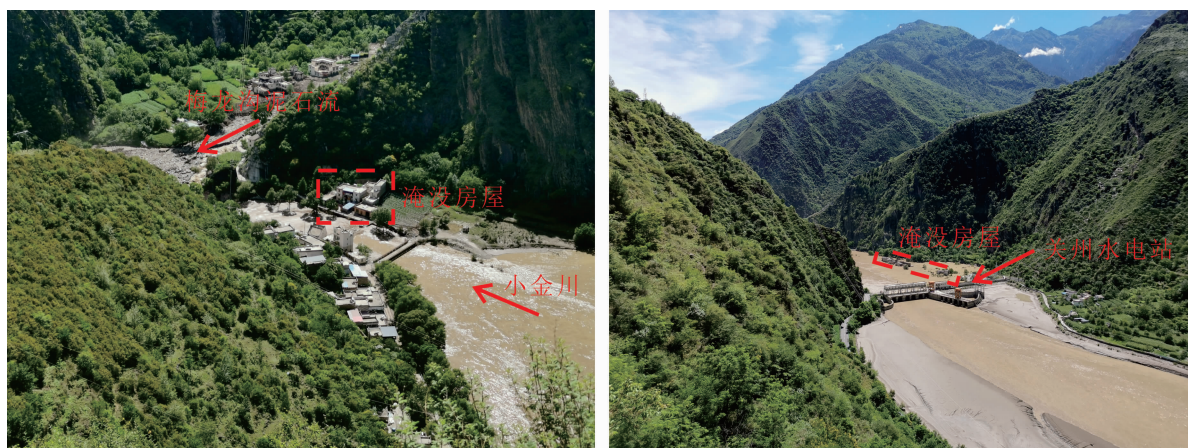
梅龙沟泥石流冲出的固体物质堆积于小金川河,局部堵塞小金川河道,压迫主河造成河流改道,致使左岸阿娘寨古滑坡坡脚失稳,古滑坡局部复活形成新的红梁木包包滑坡和烂水湾滑坡,共约 $2 \times 10^5 \text{ m}^3$ 滑坡体滑入小金川河,形成一个顺河长约 200 m,宽约 50~100 m,高约 8~12 m 的堰塞坝。堰塞湖回水至关州电站大坝,回水长度约 700 m,回水面积约 0.2 km^2 ,造成关村大量房屋被淹没

图7 关州村被淹没房屋

Fig. 7 Flooded houses in Guanzhou village
