引用格式:张友谊,钟磊,樊晓一,顾成壮,田述军.岷江河谷锄头沟震后泥石流致灾模式[J].山地学报,2021,39(5):756-766.

## 岷江河谷锄头沟震后泥石流致灾模式

**摘要:** 锄头沟位于岷江河谷汶川县绵虬镇羌锋村,是汶川地震震后大型活跃型泥石流沟,震后大规模泥石流活动造成锄头沟泥石流拦挡工程失效,多次淤积损毁都汶高速公路 G317 和国道 G213。震后泥石流治理工程对泥石流的发展起到一定遏制作用,也改变了泥石流的致灾模式。本文通过实地调查与数据分析,探讨了 2019 年 8.20 锄头沟泥石流的成因及对工程设施的致灾模式,提出了拦挡坝对翻坝泥石流能力的放大机理。研究表明:(1) 锄头沟 8.20 泥石流灾害是由各支沟暴发、主沟铲刮而形成的大规模泥石流,受侵蚀铲刮效应影响其冲出规模放大约 44.2%;(2) 锄头沟泥石流致灾模式主要为:翻坝加速、侵蚀铲刮、侧蚀强烈、弯道雍高、磨蚀槽底、堵断桥涵、冲淤民房;(3) 锄头沟泥石流现仍处于发展壮年期,在未来 10~20 年内遇强降雨仍会暴发大规模泥石流;(4) 翻坝泥石流的破坏能力和拦砂坝坝高及过坝运动速度密切相关,当初速度为 2 m/s、坝高 25 m 时,泥石流入射速度是初速度的 11.1 倍,故有效坝高较高、速度较低的翻坝泥石流对坝下的沟道仍具有很强的冲蚀能力;(5) 当过坝泥石流初速度一定时,有效坝高对翻坝泥石流的水平距离的增幅呈下降趋势,这可为坝下副坝位置的选取或护坦尺寸的设置提供科学依据。

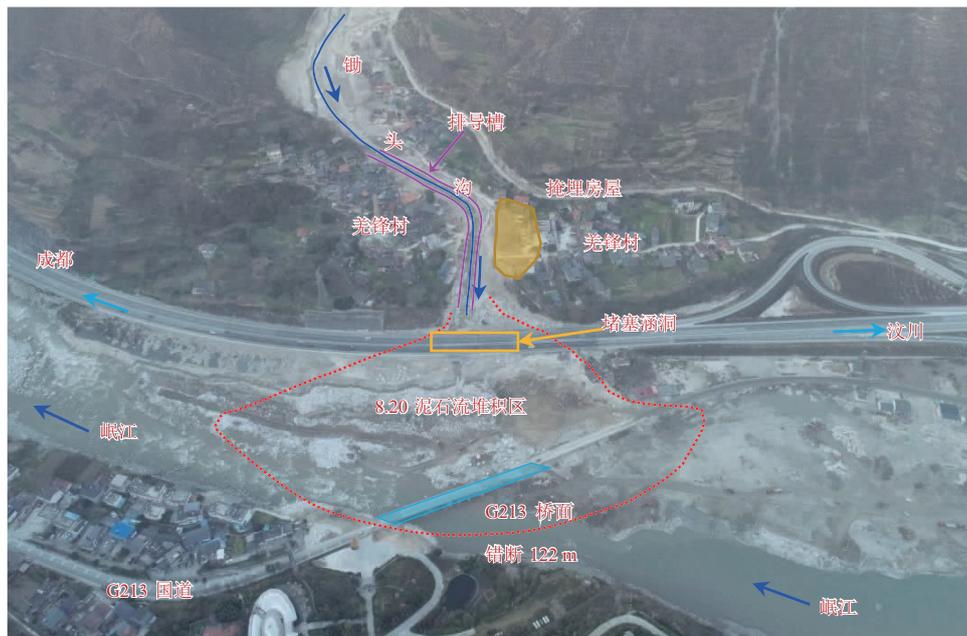
锄头沟位于汶川县绵虬镇羌锋村,为岷江右岸一级支流,距绵虬场镇约 1.5 km,都汶高速公路桩号 K93+500,沟口地理坐标为东经 103°28′46.5″,北纬 31°20′28.0″。2019 年 8 月 20 日凌晨 2 时许,锄头沟暴发泥石流,约  $75 \times 10^4 \text{ m}^3$  的固体物质从沟口冲出,凌晨 3 点左右岷江河道发生严重堵塞,回水长度向上游约 1.6 km,水位壅高至加油站老桥附近,回水高差达 14 m,持续时间约 2 h。泥石流导致羌锋村 10 余户房屋被掩埋损毁,沟口都汶高速公路被淤埋约 200 m,国道 G213 线高店大桥被冲断长达 122 m(图 1)。该次特大泥石流灾害造成锄头沟泥石流拦挡工程失效,泥石流翻坝、防护堤及护岸墙等防护工程损毁、排导槽局部冲毁、居民房屋被掩埋,沟道中下游被抬高 5~10 m,造成上亿元的经济损

图 1 锄头沟 8.20 泥石流灾害沟口(2019-12-07 摄)

Fig. 1 The gully mouth of debris flow on August 20 of Chutou gully (Photo taken on December 7, 2019)

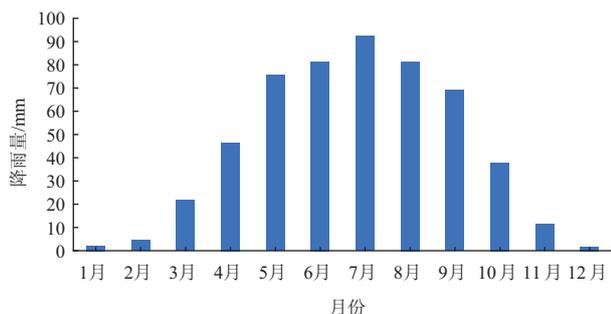
研究区属大陆性半干旱季风气候区,据汶川气象站 23 年实测(图 2),多年平均降雨 526.3 mm,最大年降水量为 648.6 mm。据调查,2019 年 8 月 19 日 0:00 至 20 日 7:00 的累积降雨量为 150 mm,20 日当天零点到七点降雨量达 65 mm,具体每小时

图2 汶川县降雨柱状图

Fig.2 Rainfall histogram in Wenchuan County

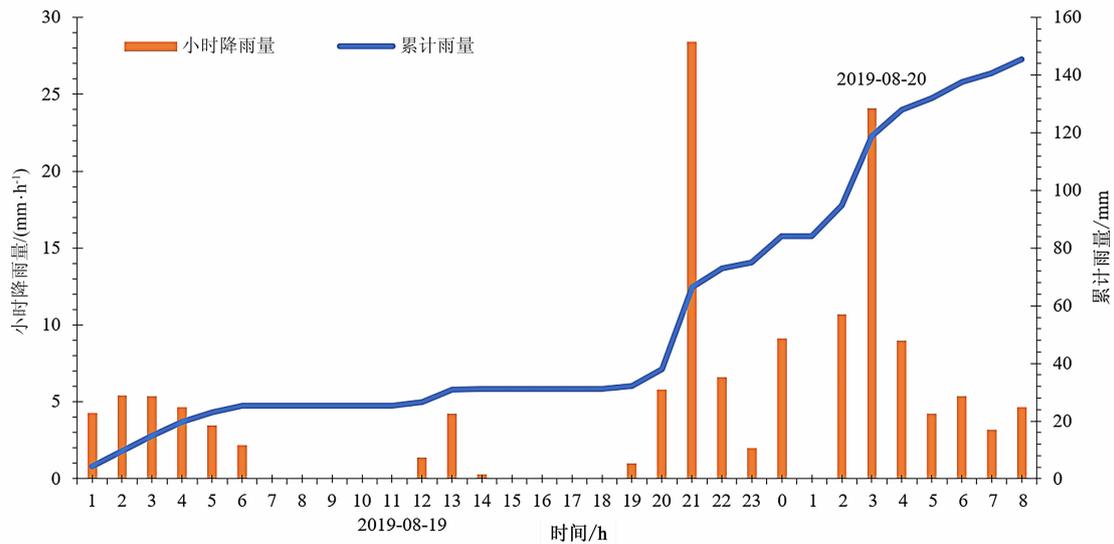
降雨量及累计降雨量(图3)。8.20泥石流灾害的激发雨强为24.2 mm/h,区内雨强达到激发泥石流的降雨条件<sup>[9]</sup>。

图 3 锄头沟 8.20 近两日降雨量<sup>[9]</sup>

Fig. 3 Rainfall of Chutou gully 8.20 in recent two days<sup>[9]</sup>

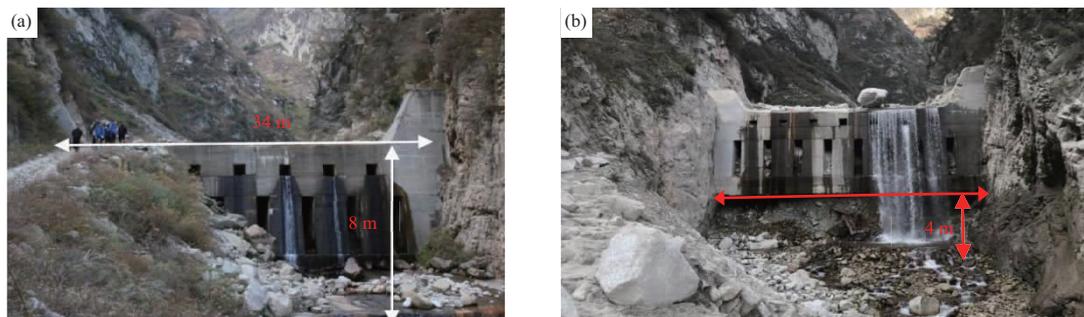
锄头沟流域主要拦挡工程为 2014 年修建的两座拦砂坝(图 4a、图 5a)和一座归流坝,拦砂坝的坝体尺寸及库容见表 4。据调查,两座拦砂坝坝体现状整体性及稳定性均较好,但其护坦均存在不同程度毁坏(图 4b、图 6),主要以翻坝泥石流的冲击、下切侵蚀破坏为主。

2# 拦砂坝有效坝高 8 m,坝下基础下切侵蚀深度 4 m(图 4b),护坦完全损毁,坝下游沟道内松散物质下切侵蚀剧烈(图 7、图 8),沿程侵蚀区长约 340 m,面积约  $8830 \text{ m}^2$ ,平均下蚀深度约 7 m,刮铲方量约  $6.2 \text{ 万 m}^3$ ;1# 拦砂坝有效坝高 19 m,坝下护坦侵蚀深约 3 m,下游沿程铲刮长 1.55 km,侵蚀铲刮区面积约  $33 \text{ 720 m}^2$ ,平均下蚀深度 5 m,侵蚀方量约  $16.8 \text{ 万 m}^3$ 。由此可见,拦挡工程在 8.20 泥石

图 4 2# 拦砂坝及护坦:(a)8.20 前;(b)8.20 后损毁

Fig. 4 2# Sand bar and retaining dam:(a) Before August 20;(b) Damage after August 20

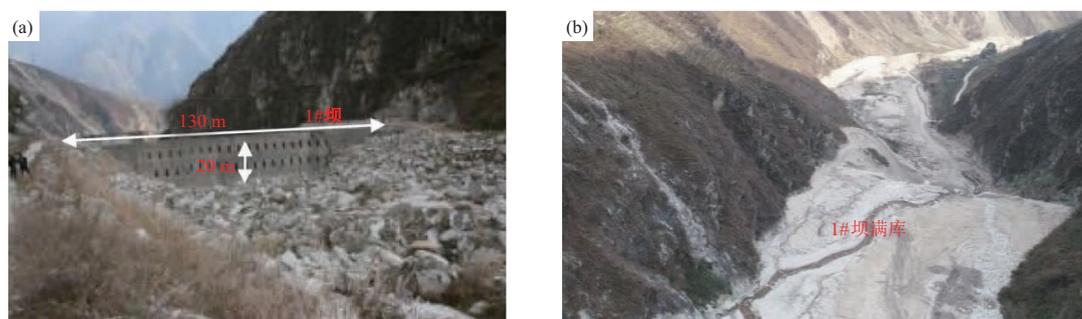
量增加  $154 \times 10^4 \text{ m}^3$ 。因此该泥石流沟仍处于活跃发展期,在强降雨作用下,未来 10~20 年内暴发大规模泥石流可能性大,如 2020 年 8 月 17 日锄头沟再次爆发大规模泥石流,清库后的 1# 拦砂坝被约  $30 \times 10^4 \text{ m}^3$  的泥石流固体物质再次淤满。因此锄头沟具备泥石流暴发的丰富固体松散物源条件。

图5 1#拦砂坝库容:(a)8.20前;(b)8.20后满库

Fig. 5 1# Dam reservoir; (a) Before August 20; (b) Full storage after August 20

(3)翻坝泥石流的下蚀刮铲能力受泥石流翻坝流速及有效坝高影响。锄头沟泥石流仍处于发展的壮年期,在未来 10~20 年内遇强降雨仍会暴发大规模泥石流,应加强既有 1#坝库容监测及时清库,以确保其有效拦挡库容。

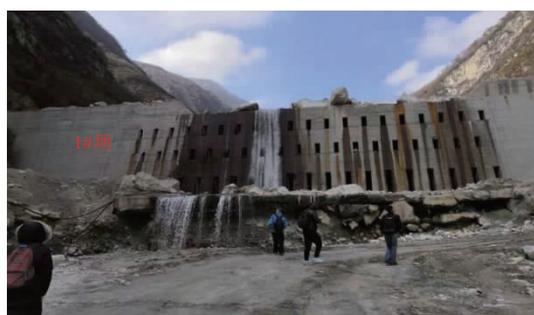
图6 1#拦砂坝护坦冲刷侵蚀悬空(8.20后)

Fig. 6 1# Sand Barrage Protector Erosion Suspension  
(after August 20)

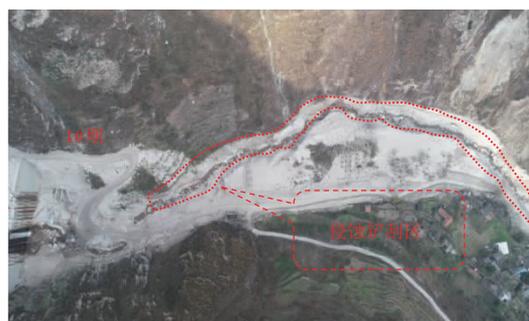
图7 1#拦砂坝下游沟道铲刮侵蚀(8.20后)

Fig. 7 Spade erosion of gully downstream of No. 1 dam  
(after August 20)

流过程中虽起到较好拦挡作用,但由于泥石流规模大,拦砂坝库容不足,泥石流翻坝后获得较大动能,对原沟道松散堆积物侵蚀铲刮效应明显,使翻坝泥石流流量及规模产生放大效应<sup>[18-22]</sup>。8.20 锄头沟泥石流流出量按 75 万方计算,泥石流经翻坝下蚀铲刮后冲出规模放大约 44.2%。

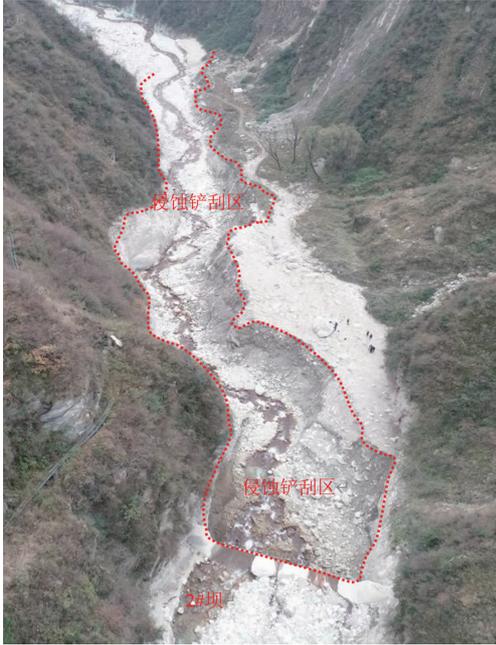
图 8 1#拦砂坝下游沟道铲刮侵蚀(8.20后)  
Fig. 8 Spade erosion of gully downstream of No. 1 dam (after August 20)

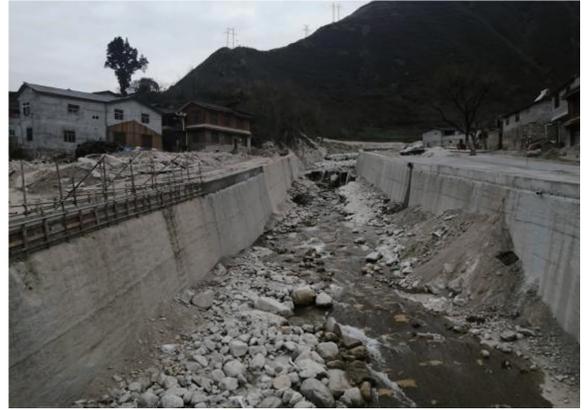
图 10 槽底损坏、侧墙磨蚀  
Fig. 10 Trough bottom damage, side wall abrasion

排导槽位于锄头沟沟口,总长 404.3 m,侧墙顶宽 0.8 m,底宽 1.7 m,高 5.5 m,基础埋深 1 m。调查期间槽内无泥石流堆积物,起到较好的束流排导作用。震区排导槽的损毁模式通常为槽底、侧墙磨蚀→槽底损毁→侧墙悬空→侧墙失稳损毁,在 8.20 泥石流作用下锄头沟沟口排导槽下游段损毁长约 140 m(图 10),侧墙及槽底磨蚀、损毁严重。排导槽弯道处(图 11),在泥石流的爬高及冲击作用下,侧墙被冲断,泥石流翻越排导槽后对居民建筑造成淤埋破坏(图 12)。

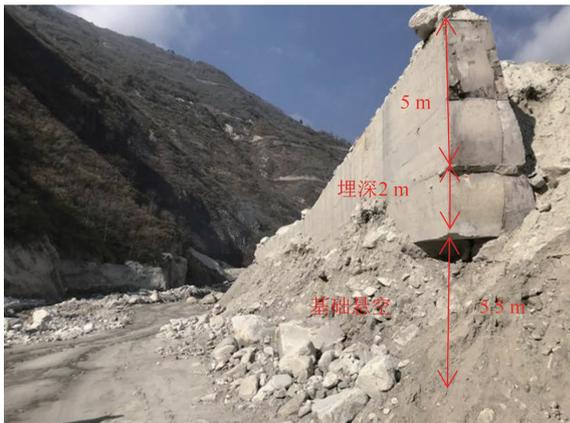
础埋深 2.0 m,护岸高度 6.0 m。防护堤位于护岸墙下游沟道左岸,长度为 572.3 m,顶宽 0.8 m,底宽 1.8 m,高 5.0 m,基础埋深 2.0 m。受 8.20 泥石流的侧蚀作用,护岸墙上游段损毁长约 18.8 m,导流丁坝被冲断;防护堤堤外被泥石流堆积物淤平,堤内由于侧蚀及沟道下切导致基础悬空(图 9),损毁段长约 78.8 m。防护堤等防护工程是震后泥石流治理最为常用的工程措施之一,类似的损毁模式<sup>[23-25]</sup>在强震区泥石流治理工程中屡见不鲜。

图 9 防护堤基础悬空  
Fig. 9 The foundation of the protective dike is suspended

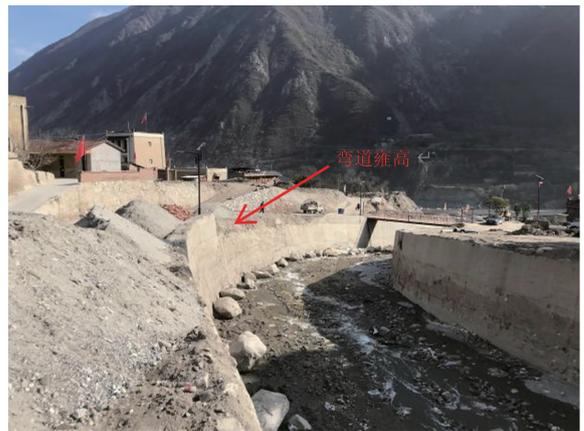
图 11 弯道雍高翻槽  
Fig. 11 Bend heightening over trough

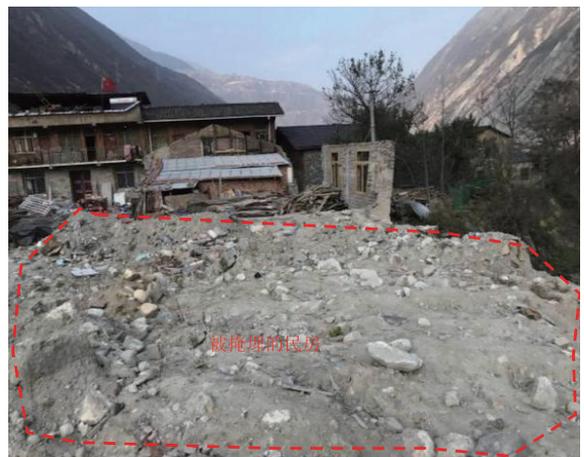
图 12 民房被冲毁淤埋  
Fig. 12 Houses destroyed and silted up

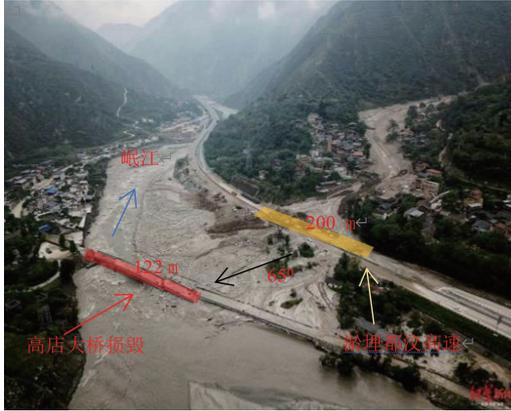
8.20 泥石流从排导槽出口冲出的固体物质,在淤满堵塞 G317 都(都江堰)汶(汶川)高速涵洞后,冲断国道 G213 高店大桥,堵塞岷江,造成岷江断

流约2小时。据现场调查,该次泥石流淤埋高速公路路面长200 m,高店大桥被冲毁段长约122 m(图13)。

图13 堵塞涵洞、冲断道路桥梁

Fig.13 Blocked culverts, washed out roads and bridges

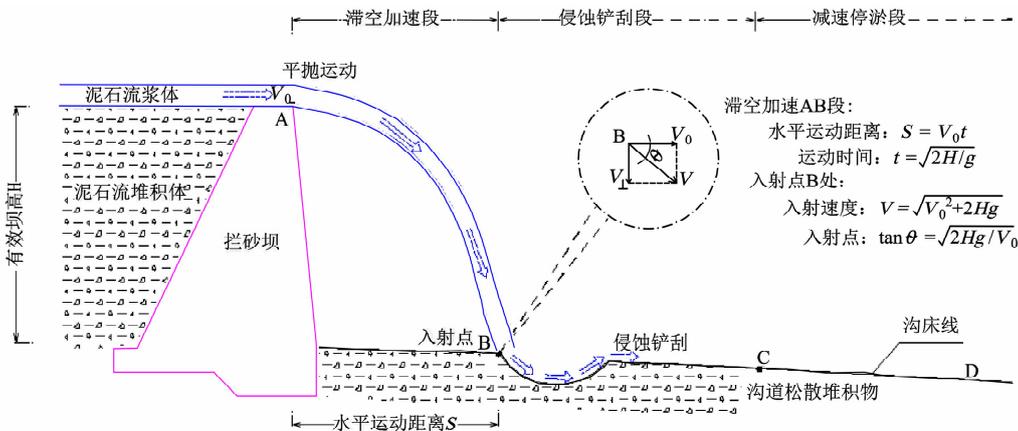
(3)(1)翻坝泥石流的运动,按其运动特征可分为:滞空加速段、侵蚀铲刮段及减速停淤段三个运动阶段(图14所示)。其中滞空加速段属平抛运动,水平运动距离、入射速度及入射角只与拦砂坝有效坝高和翻坝初速度有关,根据平抛运动方程可知(未考虑泥深):

$$\text{水平方向位移: } S = V_0\sqrt{2Hg} \quad (1)$$

$$\text{入射速度: } V = \sqrt{V_0^2 + 2Hg} \quad (2)$$

$$\tan\theta = \sqrt{2Hg}/V_0 \quad (3)$$

式中, $V_0$ 为翻坝初速度( $\text{m}\cdot\text{s}^{-1}$ ); $H$ 为有效坝高( $\text{m}$ ); $g$ 为重力加速度( $\text{m}\cdot\text{s}^{-2}$ )。

图14 翻坝泥石流运动模型

Fig.14 Movement model of debris flow over dam

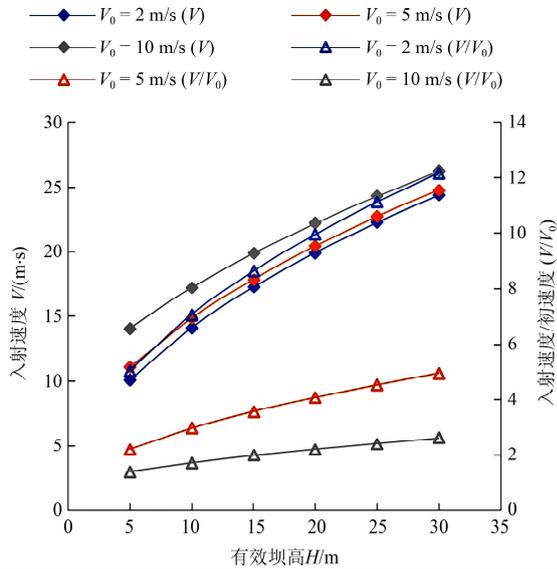
由图15可知,随有效坝高的增加入射速度呈增加趋势。随有效坝高的增加,初速度愈小,翻坝泥石流入射速度的增幅愈大,因此翻坝速度较低的泥石流对坝下的沟道仍具有较强的冲蚀能力。

图 15 入射速度与坝高、初速度关系图

Fig. 15 Relationship between incident velocity and dam height and initial velocity

震后泥石流治理工程中拦砂坝高度一般在5~30 m(高度小于5 m为谷坊坝,汶川震区已治理拦砂坝工程最大坝高25 m),泥石流速度一般小于10 m/s,结合上述滞空加速阶段的物理模型,可知翻坝泥石流在入射到沟道时的速度及水平运动距离,如图15、图16所示。

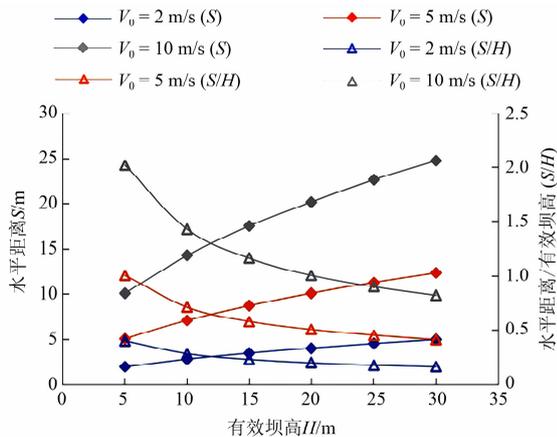
图 16 水平运动距离与坝高、初速度关系图

Fig. 16 Relationship between horizontal distance and dam height and initial velocity

由图 16 可知,有效坝越高,翻坝泥石流水平运动距离越大。初速度一定时,坝高对翻坝泥石流的水平距离的增幅呈下降趋势,这可为坝下副坝位置的选取或护坦尺寸的设定提供科学依据。
